TOWPATH TRACKS

Newsletter of the Whitewater Valley Railroad
Connersville, Indiana USA

June 2026

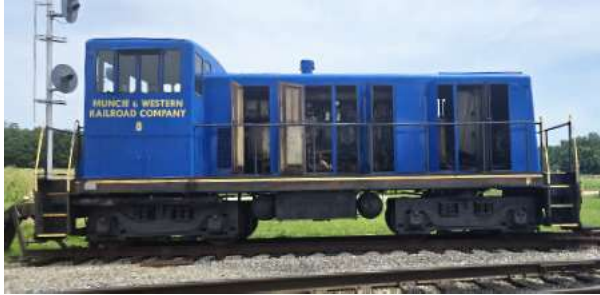
M&W #8

We have decided to explore the feasibility of restoring #8 to operation. We know that it had water-leak issues in at least one of the cylinders. Our approach at this point will be to work with the company that originally manufactured the diesel engine, Cooper Bessemer, to see what parts support they may be able to give us. That's always an issue when working on historic railroad equipment. The answer to this question will help us to craft a plan on how best to proceed.

In the photo on the left, the engine room doors have been lubricated so they will open freely. Now, we'll be able to perform a closer inspection.

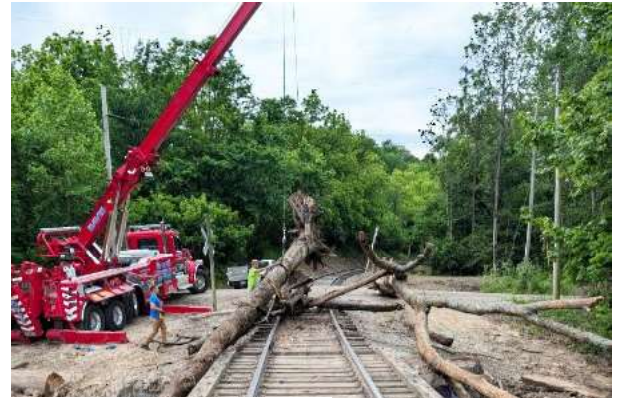
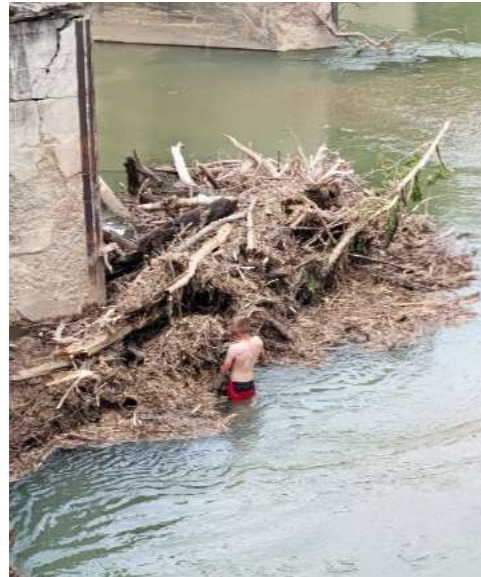
Track Update

Earlier this year we had a large amount of downed trees removed from the abutments of the Laurel Bridge. Trees that have fallen in the river make their way downstream and then become lodged against the south piers of the Laurel Bridge. This causes other trees and debris to jam up, thus changing water flow. In spite of earlier efforts, the trees started piling up again. To

prevent another major logjam, we decided to bring in Davis Towing and use them to clear things up.

They used one of their rotator wreckers to drag the trees up the embankment and create a pile clear of the bridge. We are hoping that doing this several times each year will be more cost effective than hiring the excavating company, and will help keep the water flowing around the bridge abutments.

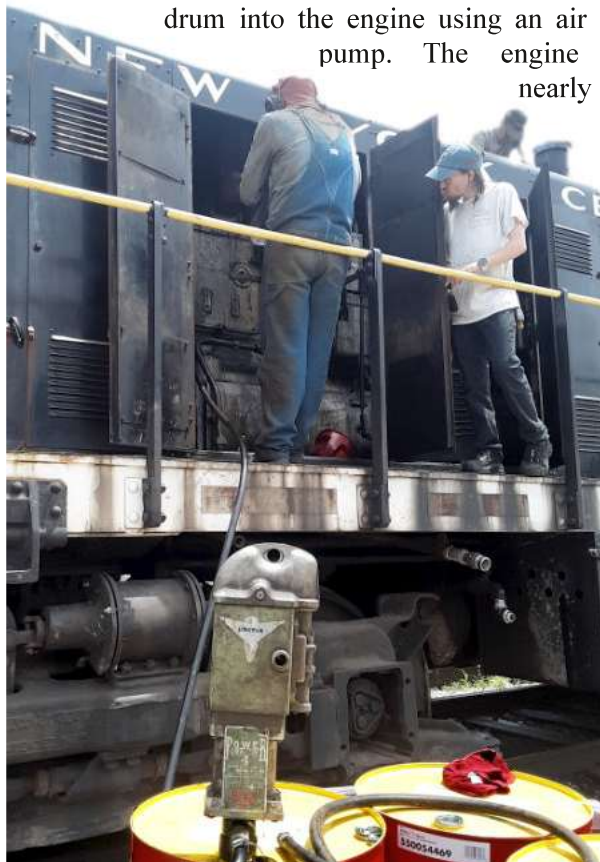
Engine 9339 was suffering from low oil pressure so we took an oil sample. The results of the oil testing revealed that there was some fuel in the oil, but not an extraordinary amount. However, the test also revealed that the oil was thinner than it should be. One likely explanation is that the low oil pressure was the result of two factors: slight fuel dilution, and worn bearings that need thick oil to maintain pressure. We drained the engine and refilled it with new 50 weight motor oil. In the photo below we're pumping oil from a 55 gallon drum into the engine using an air driven pump. The engine holds nearly two

55 gallon drums of oil. Also in the photo, Ryan Scott is on top of the locomotive inspecting the intake and exhaust valve rockers. One set was not receiving oil as it should, so Ryan was cleaning and using compressed air to blow out oil passages. The locomotive is now back in service.

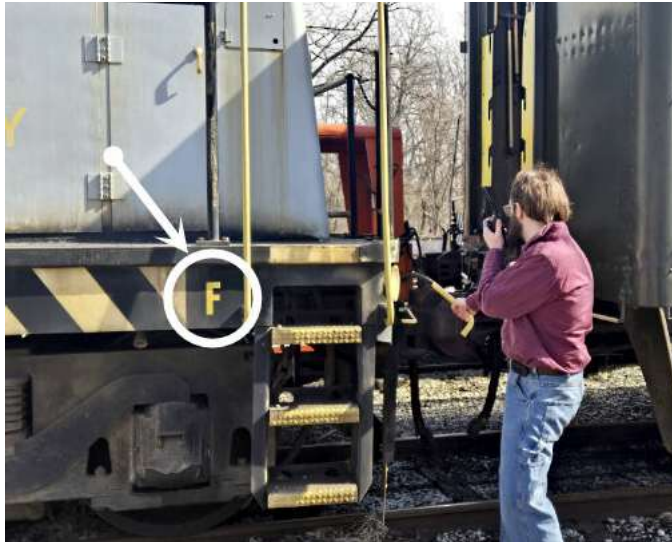
Forward or Back?

In this photo the brakeman has just lifted the uncoupling lever to separate the locomotive from the train. Would the brakeman tell the engineer to go forward, or to move backward? The key to answering that question is the letter “F” near the steps on the locomotive. That designates that this is the “Front” of the locomotive. So, in this case, the brakeman will tell the engineer to back up to move away from the train.

Federal Railroad Administration (FRA) regulation §229.11 requires that “The letter “F” shall be legibly shown on each side of every locomotive near the end which for identification purposes will be known as the front end.” Some locomotives, such as our NAVY 1, don't have a clear front or back, since the cab is in the center. Also, in the early days of diesel locomotives, some railroads ran the engines with the long hood forward. Their thinking was that this provided better crash protection. So, to avoid confusion, locomotives are marked with an “F”.
