## Newsletter of the Whitewater Valley Railroad Connersville, Indiana USA

# Record Rainfall & Flooding

Throughout the Whitewater River Valley

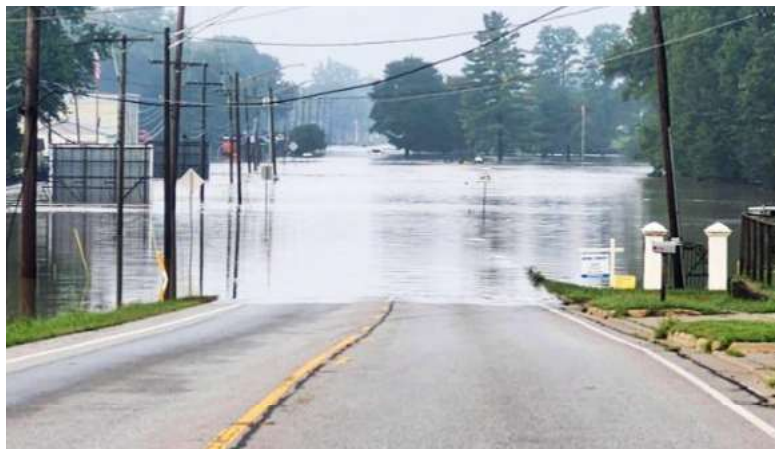
This photo was taken from Route 121 at the height of the flooding. In the distance on the left you can see our shop and the familiar orange color of engine 532.

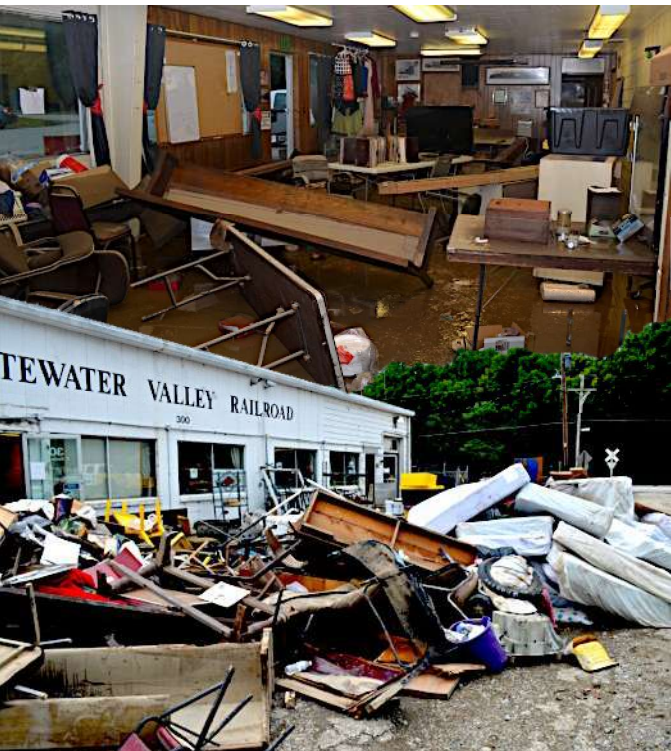
The interior photo above shows the disarray left behind when the waters receded. The first day was spent removing the contents of the building and stacking it outside. Periodically, a crew comes by, loads the debris, and hauls it to a staging area at the Connersville Airport awaiting final disposal.

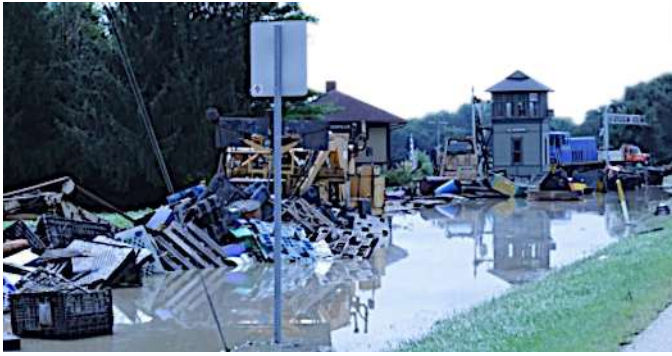
It's amazing the amount of debris that the flowing water carried away. Quite a bit of it came to rest on our main track down by the Rushville Depot and Dearborn Tower. It will need to be moved and consolidated for pickup. The standing water sitting in what remains of the canal bed has since receded.

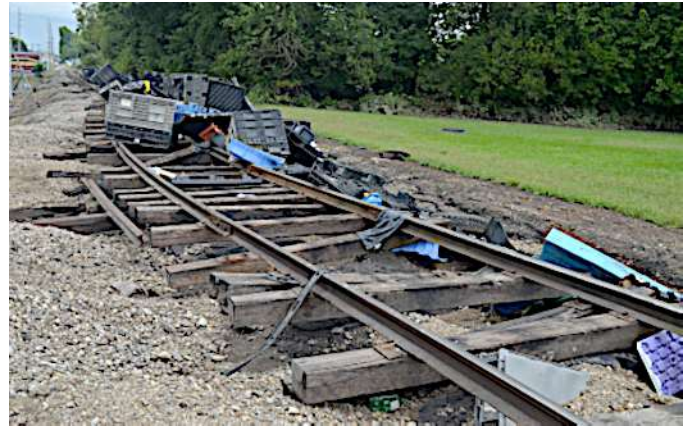
This is a washout just north of Eastern Avenue. The flowing water not only washed away the ballast, but it also moved the track several feet out of alignment.

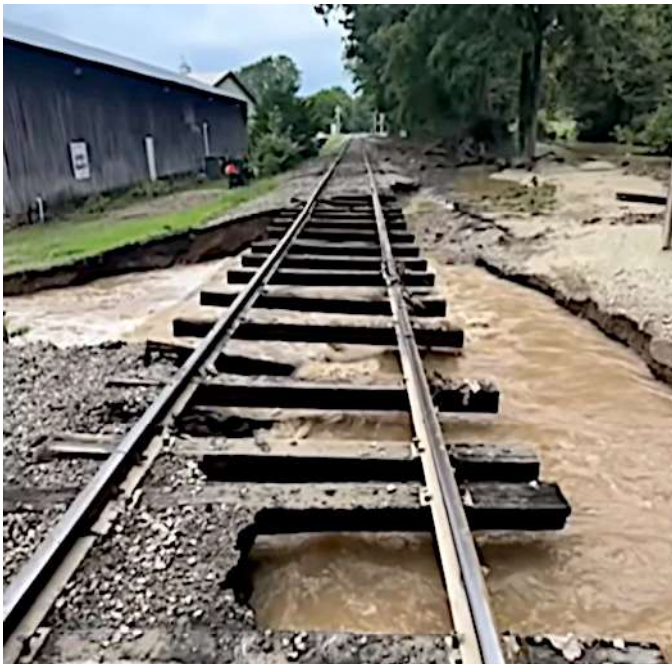
This photo was taken in Metamora after the water had started to recede, but it still had a heavy flow to it. Water on its way to the river will make a path. Unfortunately, washouts like this occurred along the entire length of the railroad.

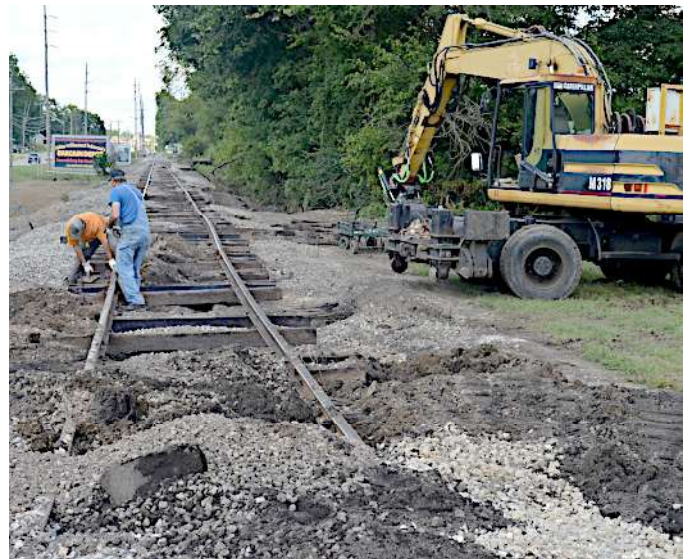
The following weekend, the debris has been cleared and repairs are being made. The current focus is to work north of Eastern, get that track repaired, and then start heading south. Unfortunately, the next washout (photo below) is only fifty feet away, with many more to come.

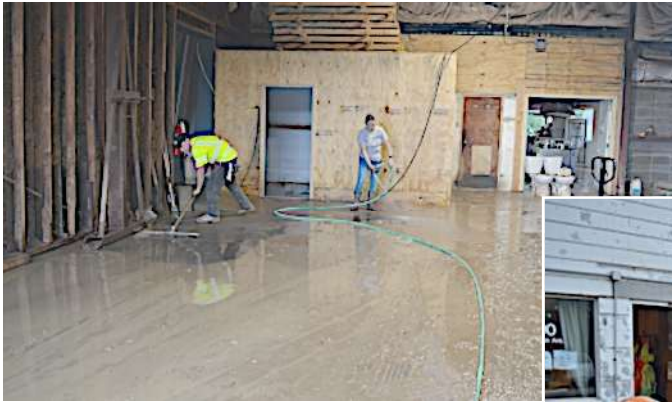
The waters left behind a coating of fine silt that covered any horizontal surface, especially floors. Here the floor in the South Conn. Annex is being cleaned with a squeegee and a hose. This building contained Polar Express merchandise left over from last year, which could not be saved. Fortunately, this year's order has not come in yet.

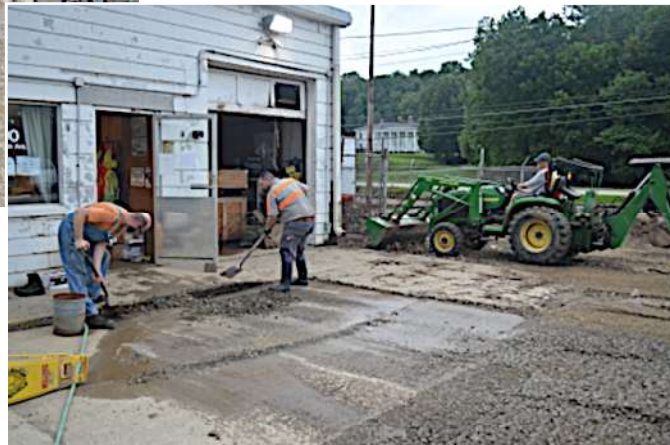
The cleanup includes moving dirt and gravel back into place. It was amazing how much material the waters moved. The overhead door in the building provides access to our air brake valve storage area. Most of our inventory was flooded and will have to be sent out for a rebuild.

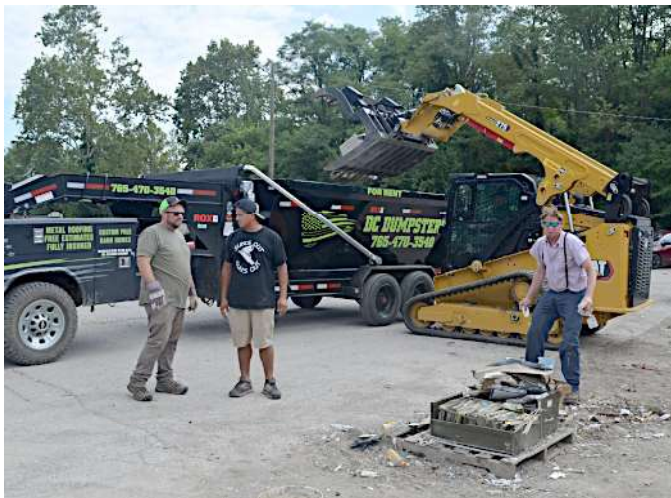
Another load of trash is being picked up. This load contained many paper records which the water destroyed. For some of the records, retention is required by Federal Railroad regulations. We have already contacted the FRA, and they instructed us to prepare a memorandum detailing the date of the flooding and extent of the damage. With this in place we would not be required to produce paper records for anything that happened prior to the flood.

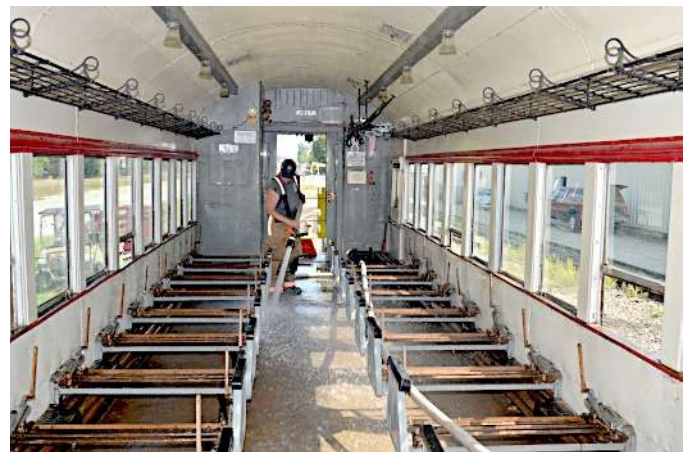
All of our coaches were parked on track 3 and the flood waters were high enough to enter the cars and flood the floor, but not cover the seats. How to clean that? Our solution was to remove all of the seats, place them outside, and then have a volunteer fire department hose down the interior. It was slow going because the silt was very stubborn. They used one tank truck of water to clean coach 9 and one caboose. This process will continue until all of the equipment has been cleaned.

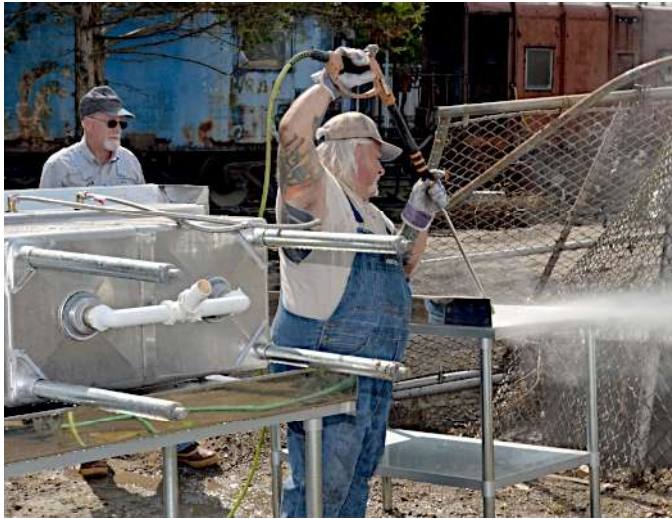
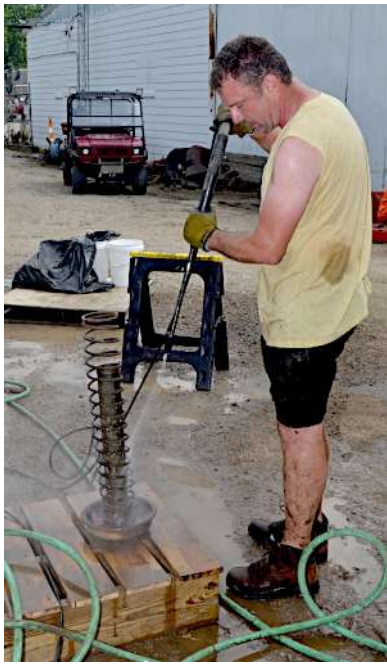
We have been putting pressure washers to good use during the cleanup process. In the photo above the stainless steel kitchen sink and counter are being cleaned so they can be reused. All of the various items stored in the shop buildings needed to be pressure washed (left). The floor of the old shop was also washed.

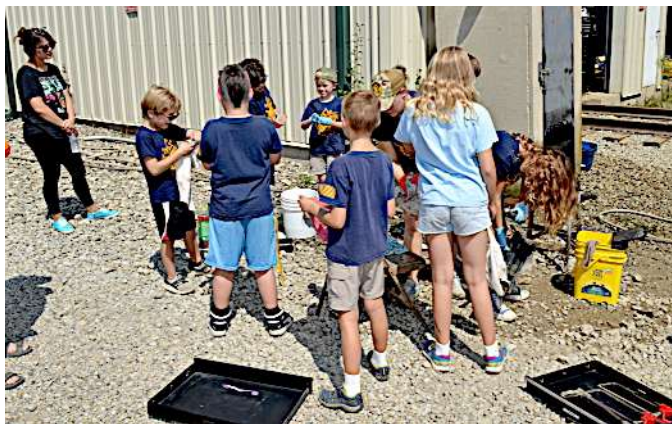
We have six rolling tool boxes in the shop, and the drawers in the lower half got flooded coating everything with brown slime. The solution was to remove the drawers and contents, clean and dry everything, and

then reinstall them. This task was handled by multiple people including a cub scout troop, and was supervised by Rusty the shop cat. She wasn't happy about the flood, but seems to have recovered.

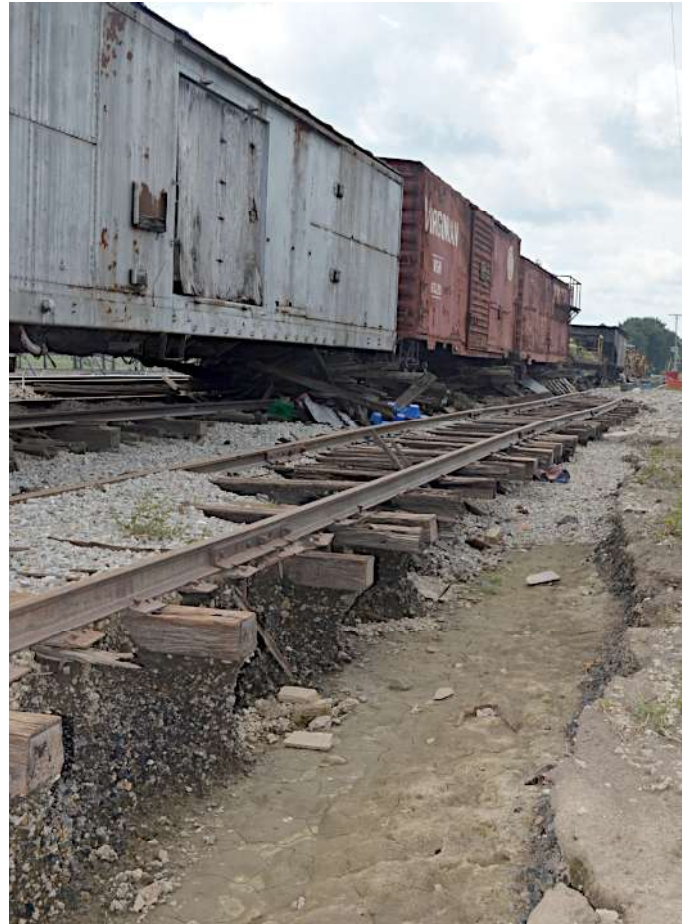
This is a view along the west side of track 3 at the south end of our yard. As you can see, the water dug a deep trench alongside the track. It also piled quite a bit of debris under the cars.

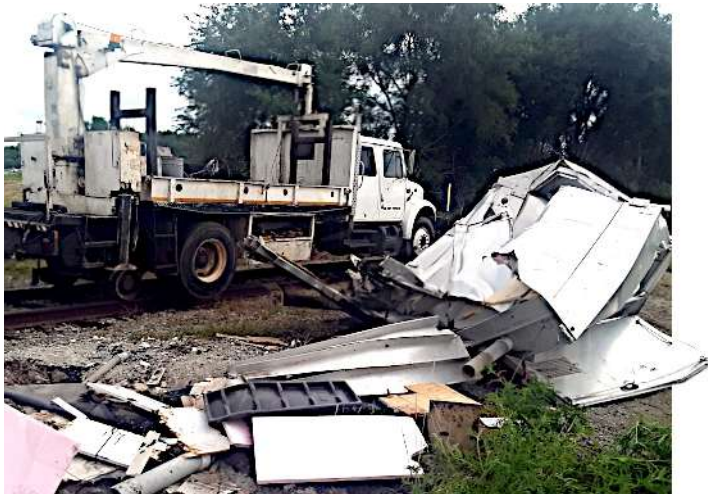
Editor's Note: This incident preceded the flood, but it is worth covering. A railroad signal bungalow is a small, weather-resistant aluminum enclosure that houses the electronics, relays, and crossing controllers for grade-crossing signals. Our tracks cross Veterans Memorial Drive just south of Connersville, and that crossing is equipped with flashing warning lights. On Saturday, July 25, there was a traffic crash where Veterans Memorial Drive crosses Route 121, which is adjacent to our tracks.

An SUV and a tractor-trailer collided, and the truck swerved across the road and impacted the signal bungalow head on. As you can see in the photo, the bungalow was destroyed. We will be filing an insurance claim for a complete replacement. In this photo our boom truck is ready to move the debris.
